Prorov za vozila u četvrti Tuen Mun u Hong Kongu

Mr. sc. Davorin Kolić,

Jacobs Babtie Ltd, Hong Kong, NR Kina

Vehicular Underpass in the Tuen Mun Area 56, Hong Kong

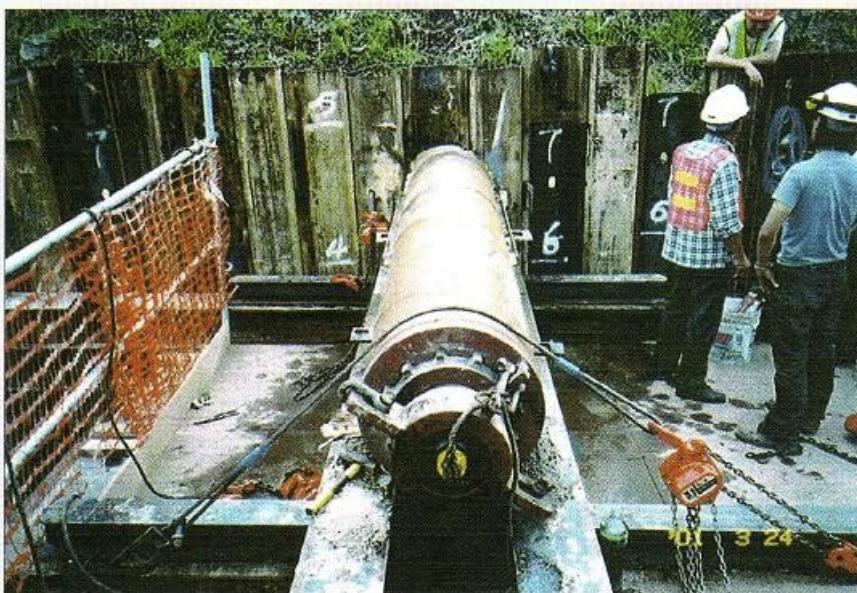
Slika 9. Zabijanje cijevi uz kraj za zabijanje

Pipe ramming was generally performed from one side (driving end) of the underpass with an exception that where the existing box culvert was present, the pipe ramming was carried out from both sides. At

the driving end, a sheet pipe wall was installed to fix the face where steel pipes were rammed toward the body of the embankment (Figure 9). At the receiving end the embankment slope was basically not protected by additional measures, instead, a careful control and observation was enforced when the pipe reached the exit point.
